# A geomorphological design for the rehabilitation of an abandoned sand quarry in central Spain

## Abstract

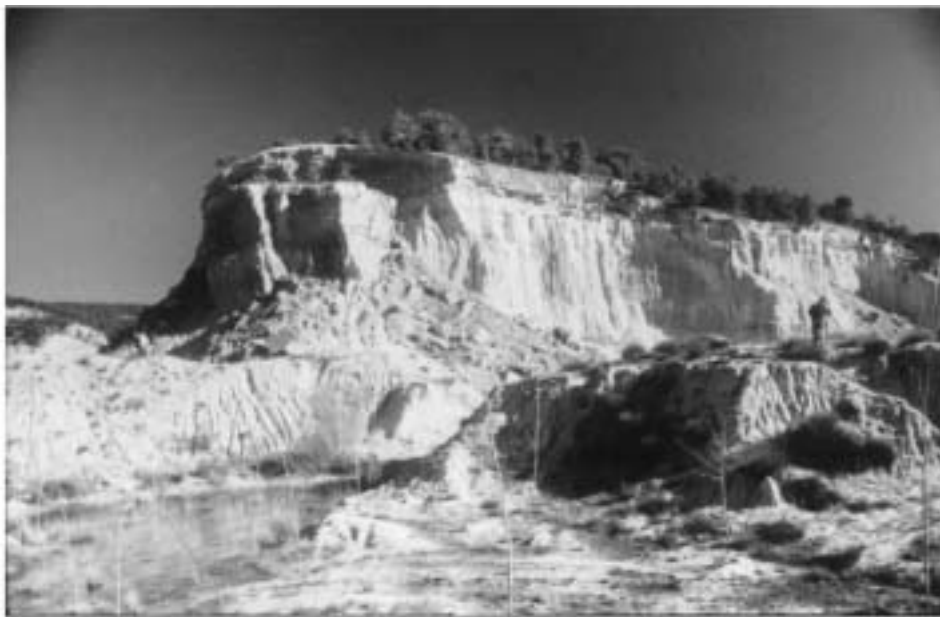
Fig. 2. General view of the west sector of the quarry prior to the rehabilitation: dispersed spoils banks affected by erosion processes, falling of blocks from the abandoned quarry face and significant impact on the ecology and landscape.

- The alterations to the initial topography affect the dynamics of the groundwater, leading to the dissection of small permeable levels and to diffuse flows or seeping on the former quarry face. Since, the resources were of scant interest, the alteration to them was not significant; however, considerable disturbance was caused by the fact that these springs perforated the sands and led to major gravitational processes

(landslides, falls) on the old quarry face (see Fig. 2).

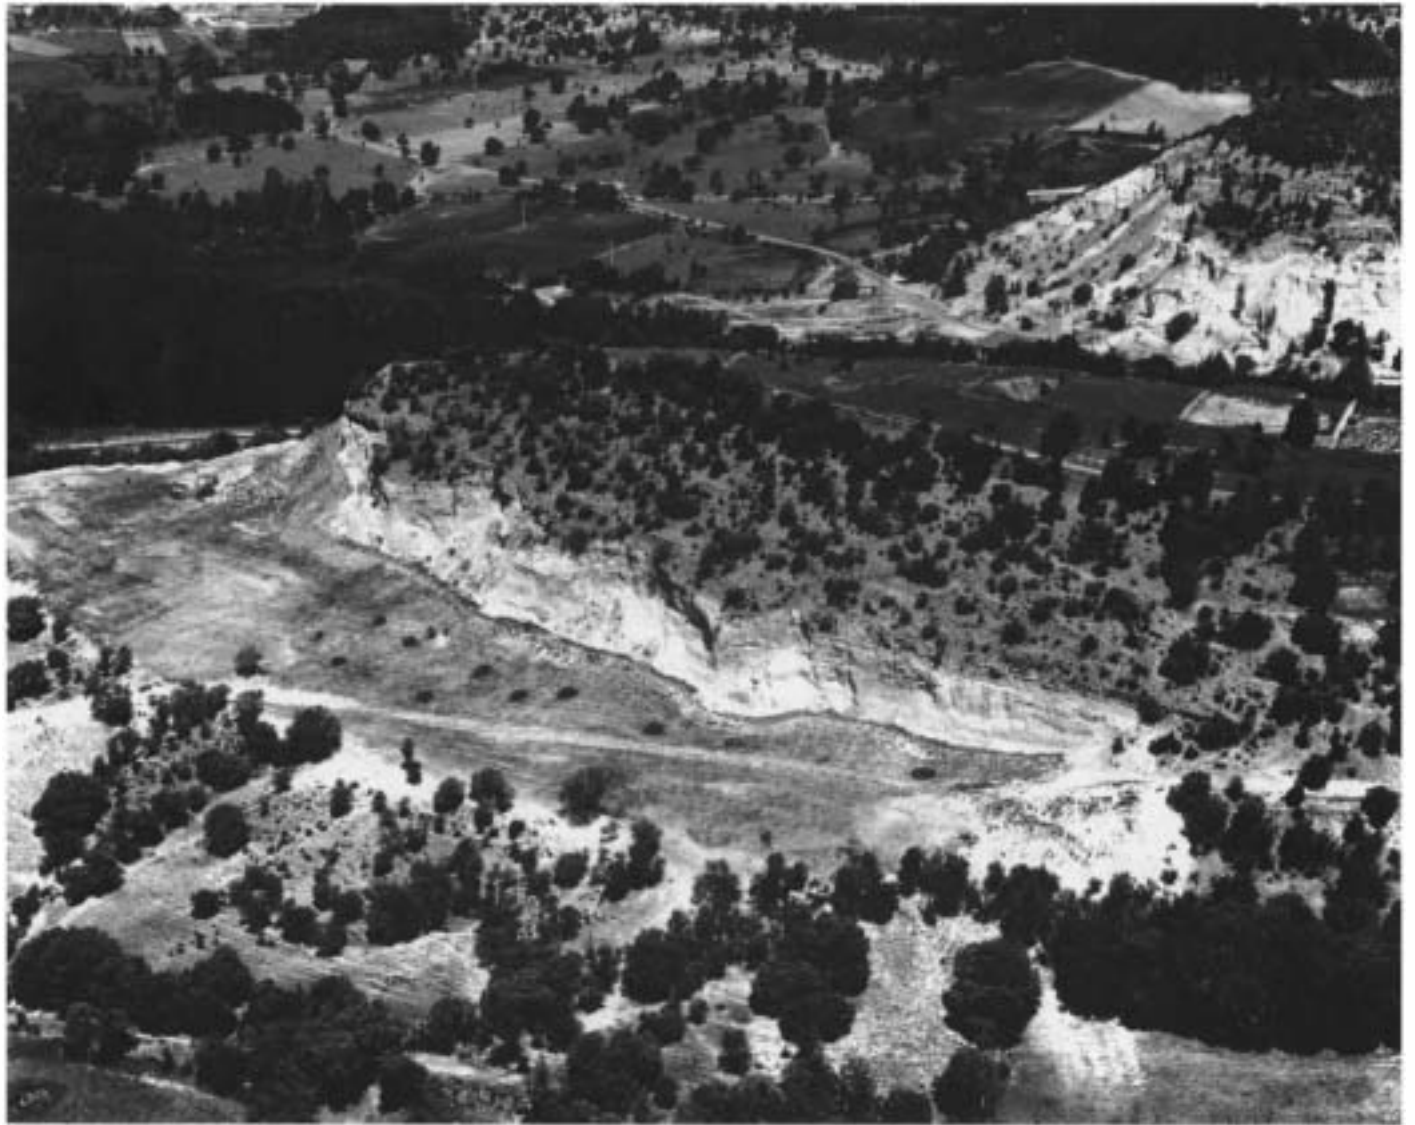
Fig. 8. Aerial view of the rehabilitated surface (May 1996). Photo: Paisajes Españoles S.A.

3. Subsequent to the rehabilitation activities, the appearance of the area is shown in Fig. 8. This situation is considered to be provisional, since, in time the terrain will acquire a dynamic equilibrium profile based on the evolution of the scarp (see Fig. 7(D)). At the same time, a vegetation colonization will occur which will eventually lead to the restoration of a wood with similar features to those of the surrounding area. The average time estimated for completion of this process is around 50 years; this assumption is based on a study of the behaviour of the adjacent slopes.

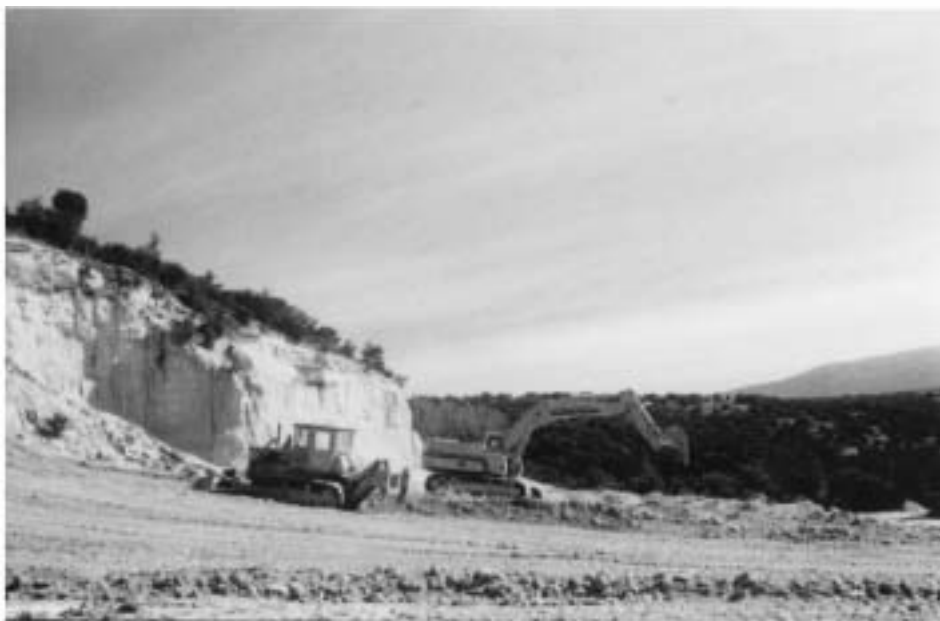
Fig. 9. The project was performed between January and February 1995. The picture shows the works relating to reconstruction of the glacial type morphology, and extending of the colluvial material on the final surface. Since the use of heavy machinery led to compaction of the terrain, decompaction work was subsequently carried out using the traditional farming techniques of the region (ripping, ploughing).

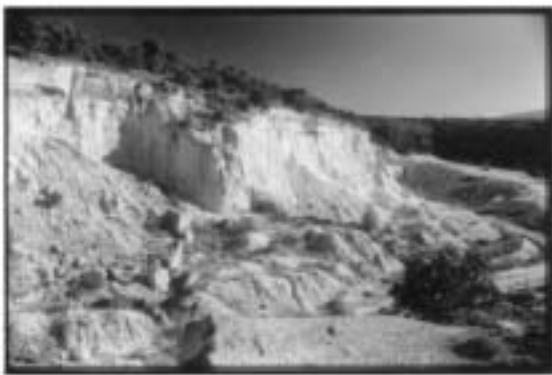
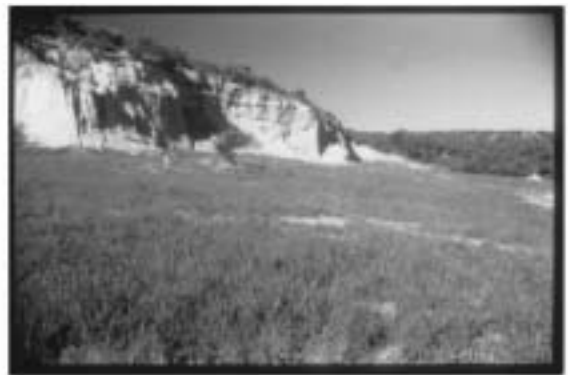
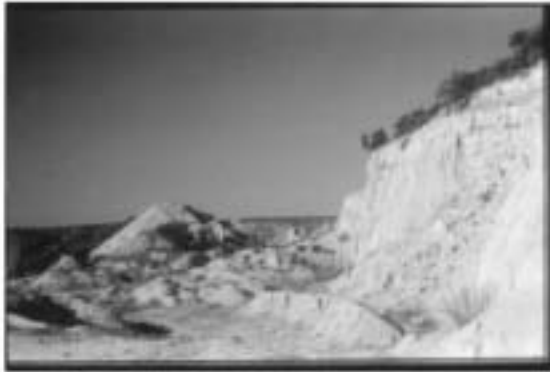
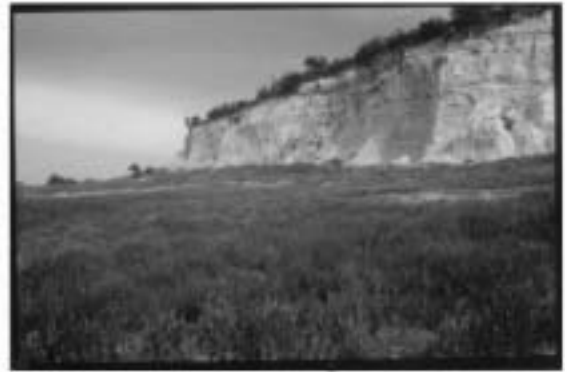
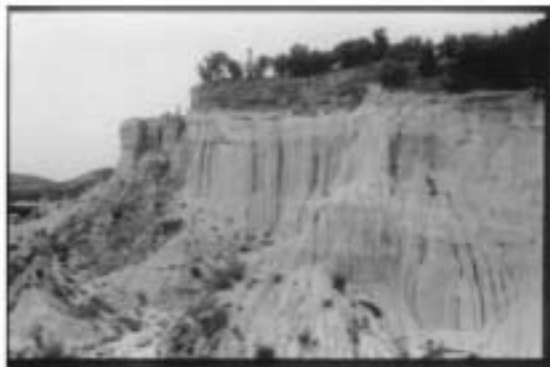
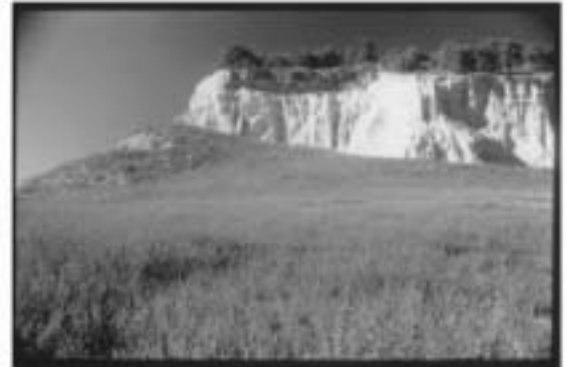
Fig. 10. Different details of the rehabilitated surface (May 1997) and comparison with the situation prior to restoration. The conditions established have enabled a satisfactory development of the vegetation cover at the slope base.

surface vegetation has been satisfactory, since practically, all the seeded area has been covered by vegetation (Fig. 10); vegetation growth has been slow in those areas, in which it was not possible to recover with the colluvial material, consequently, causing the soil to develop on a sand substratum (only *Lolium rigidum* adapts to this type of substratum, and only in
